Solar Wind Induced Substrate Alteration on Genesis Array Materials and H⁺ Diffusion at L1

Genesis Solar Wind Curation
Astromaterials Acquisition and Curation Division
NASA Johnson Space Center

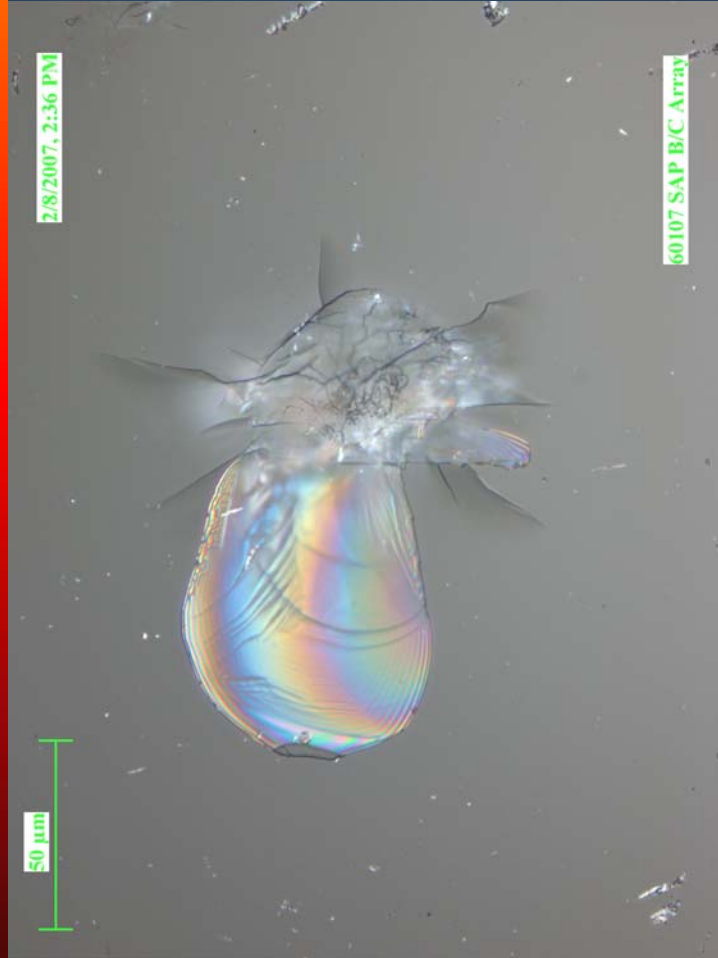
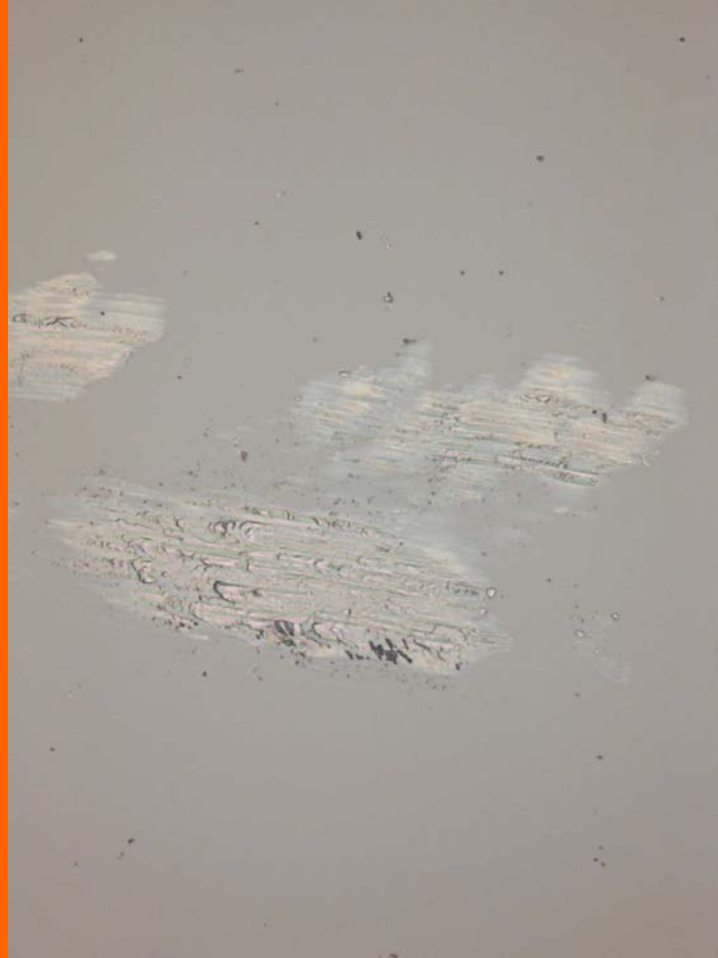
Review of Surface Contamination after UPW/Megasonic Treatment

- Molecular Contamination (Brown stain remains)
- Very little surface particle contamination remains
- UPW treatment does remove some statically charged particles
- Impact Craters still have small particles around craters
- Melted and fused materials are not removed
- Fused materials are 90 % other wafer fragments
- Still Unknown Contamination

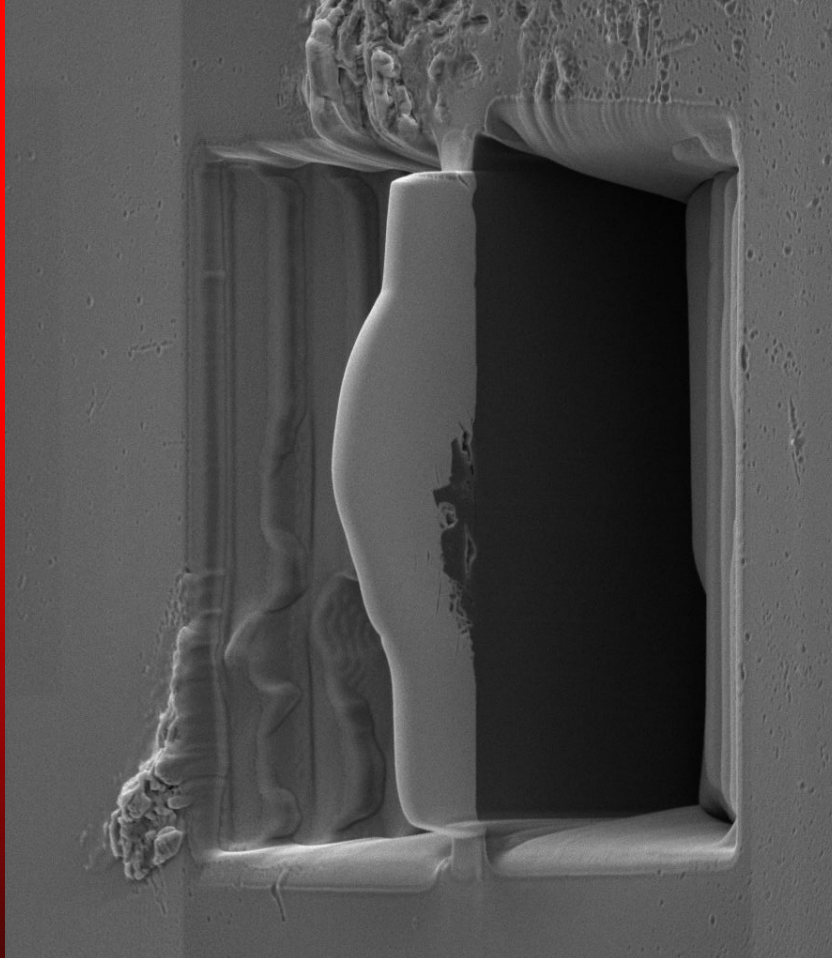
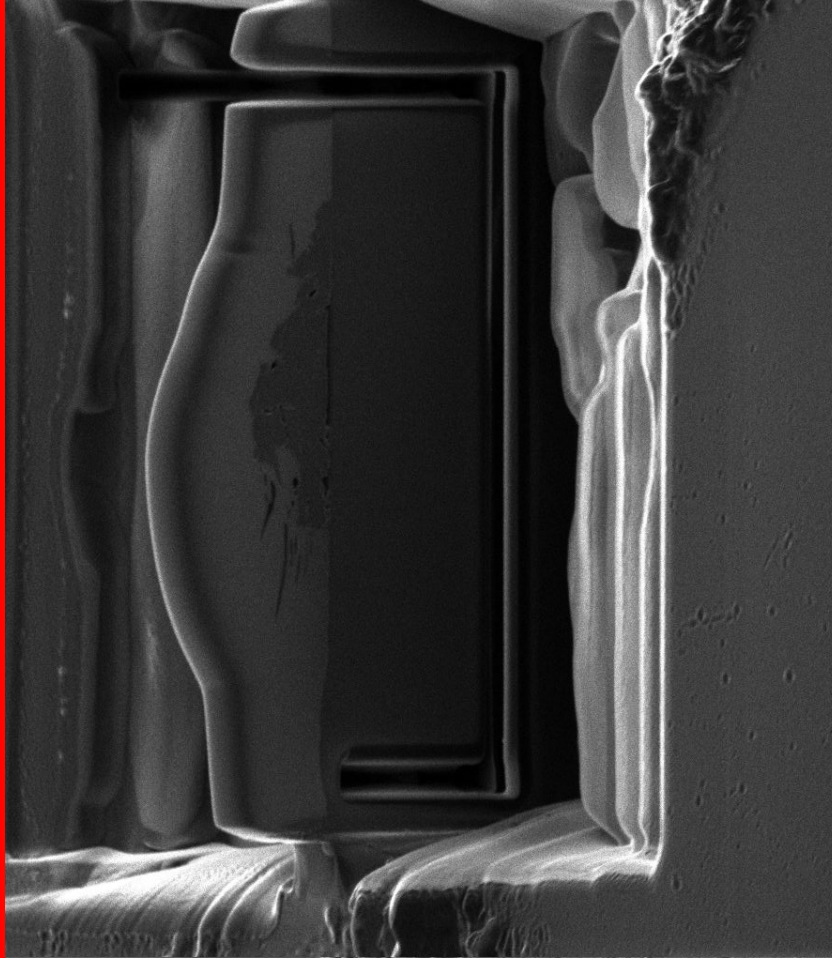
Ion Milling Startigraphic Cross-section

HV	5.00 kV	curr	98 pA	mag	8 000 x	WD	5.0 mm	tilt	53 °	det	ETD	10 µm	label
----	---------	------	-------	-----	---------	----	--------	------	------	-----	-----	-------	-------

HV	30.00 kV	curr	30 pA	mag	5 000 x	WD	19.6 mm	tilt	-0 °	det	ETD	10 µm
----	----------	------	-------	-----	---------	----	---------	------	------	-----	-----	-------

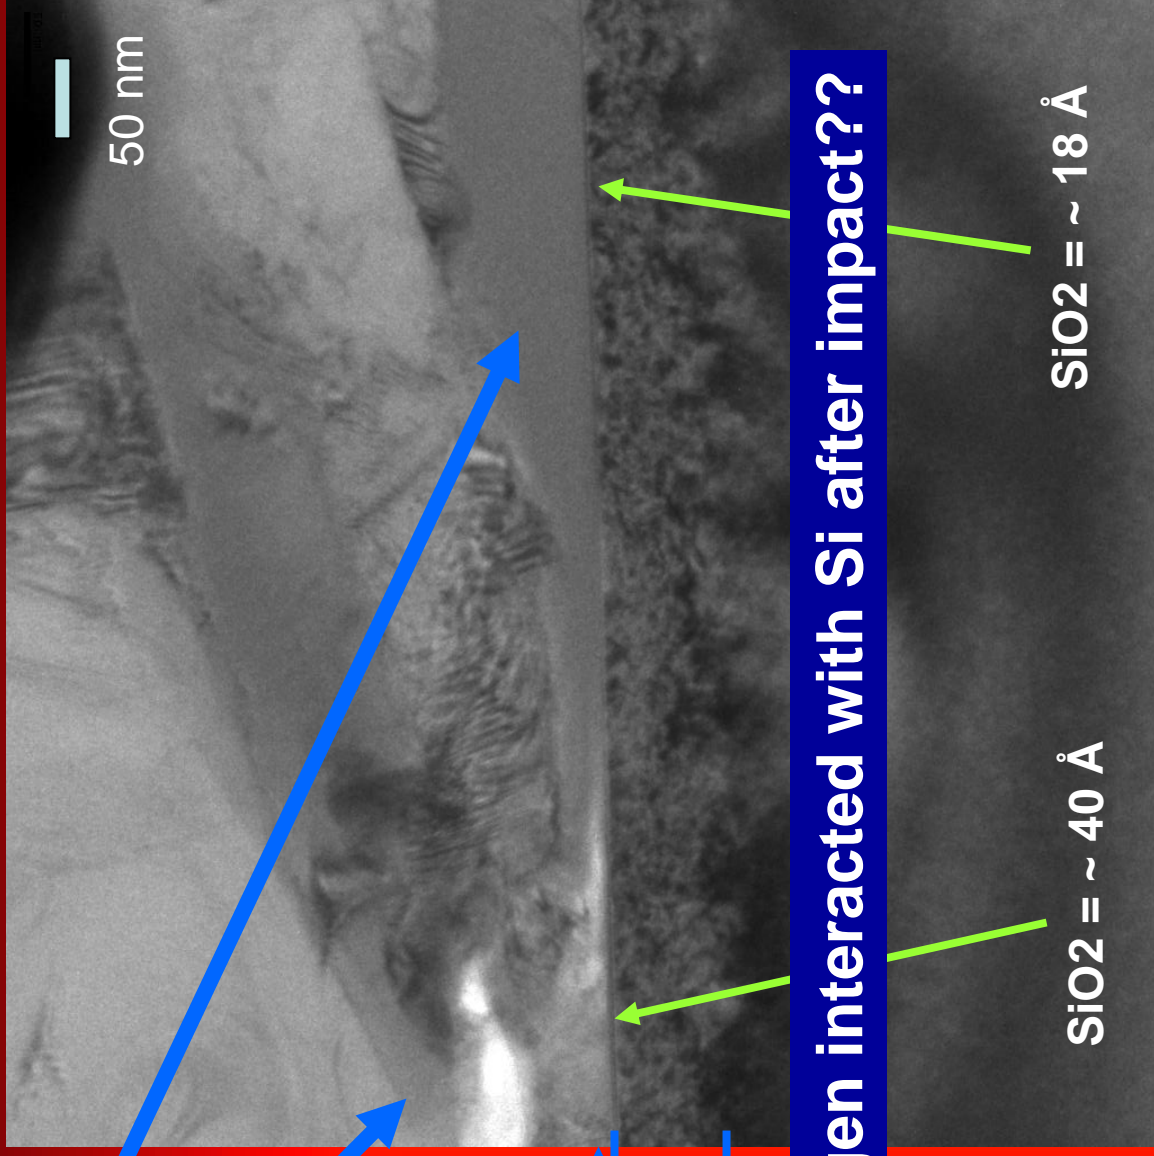
STEM Image of 60208.4 Si B/C Array

a-Si Particle

c-Si Particle

Wafer Surface

Native Oxide Layer

Atmospheric Oxygen interacted with Si after impact??

Radiation

Damage Zone

- Analysis of elemental abundances must take into account changes in the substrate lattice structure due to solar wind radiation damage that may have occurred throughout the implantation time.
- A radiation damaged native oxide layer may have allowed a reaction between atmospheric oxygen and Si substrate after impact. This caused new growth of the native oxide layer that came to a new equilibrium at 30 to 60Å.
- Should we rethink thin-film contamination on array materials (brown stain hypothesis).
